Makara Estuary Monitoring: Effects-based monitoring within a degraded, yet dynamic, coastal environment.

Tim R. Haggitt¹ and Shaw T. Mead¹

¹ eCoast Ltd, Raglan, New Zealand; t.haggitt@ecoast.co.nz

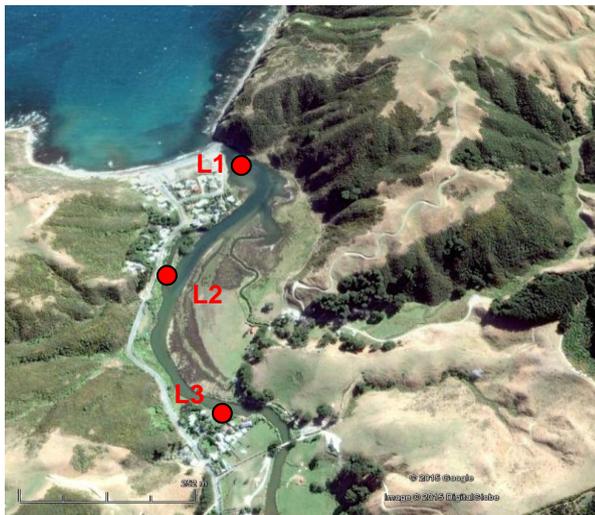
Figure 1. Biological and physical monitoring locations within the Makara Estuary. L1 – entrance (41° 13' 12.94" S; 174° 42' 56.51" E); L2 – 400m upstream from entrance (41° 13' 22.19" S; 174° 42' 50.07" E); and L3 – 800m from entrance (41° 13' 30.59" S; 174° 42' 57.70" E).

For the initial pre-construction survey a total of 3 locations within the Makara Estuary were sampled (Figure 1). These same locations were re-sampled for all subsequent construction-phase surveys. The 3 locations were:

1. the inner entrance and lagoon;
2. 400 m upstream of the entrance; and,
3. 800 m upstream of the entrance.

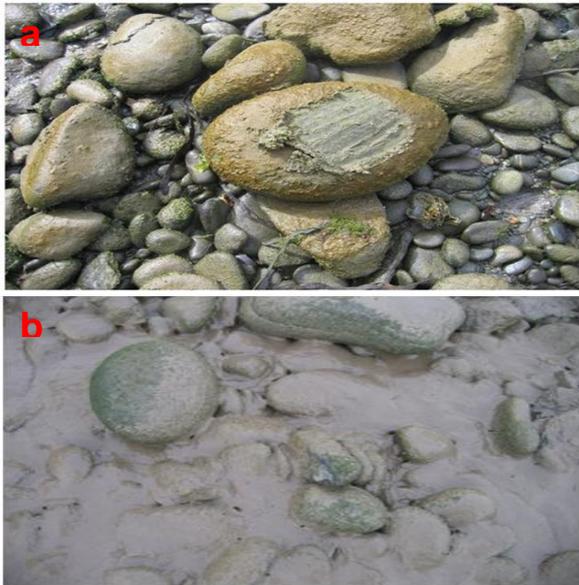
Figure 4. Intertidal cobble habitat at Location 1 illustrating nature of sedimentation between autumn 2012 (a) and spring 2012 (b) pre-construction phase surveys.

The first two pre-construction phase surveys revealed an extremely degraded estuary. This was evident at all 3 locations, which were characterised by homogeneous, fine, anoxic, silty mud; patches of decaying macroalgae (Location 1); various states of bank erosion (active, slow and historic) throughout the estuary; and, *ad hoc* reclamation (Location 3). Average taxa richness (epifauna and infauna combined) was uniformly low at all locations being < 3 species.core⁻¹ for both surveys (Figure 2). Polychaete fauna enumerated from infaunal cores were also synonymous of degraded environments (Figure 3). There was widespread deposition of fine sediment on intertidal cobble habitat and mudflats at Location 1 during the second pre-construction survey, suggesting that sedimentation was impacting the estuary prior to wind farm development (Figure 4).
