# Application of Climate Change Adaptation, Resilience, and Beach Management Strategies on Coral Islands

Shaw Mead<sup>1&2</sup> Jose Borrero<sup>1</sup> David Phillips<sup>1&2</sup> and Ed Atkin<sup>1</sup>

<sup>1</sup> eCoast Marine Consulting and Research, Raglan, New Zealand; [s.mead@ecoast.co.nz](mailto:s.mead@ecoast.co.nz)

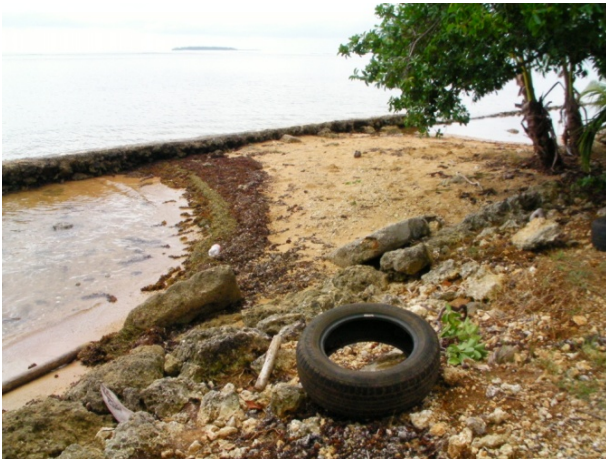
Figure 2 A tombolo formed in the lee of a failed seawall at eastern Manuka.

The first pilot site is on the eastern end of the area of interest, at Manuka Village. This is the most wave-exposed of the sites. Given the short-period wave climate, detached breakwaters were considered as a viable option to reduce the loss of sand and provide a wider buffer zone to reduce/prevent erosion and over-topping. Remnants of a failed seawall at the site indicated that detached structures could indeed capture sand behind them, and coastal plant species had also established in these protected areas (Figure 2).

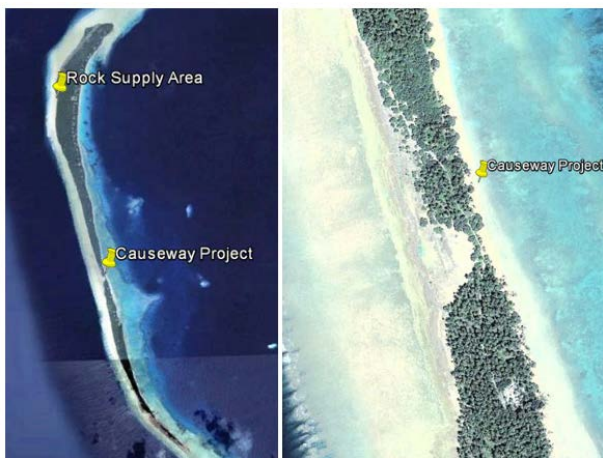
Figure 4 Location of the project site and potential construction material area. (Source: Google Earth).

A second GCCA:PSIS funded climate change resilience demonstration project is also underway on Woja Islands, Ailinglaplap Atoll in the Marshall Islands (Figure 4). The Marshall Islands is one of the most vulnerable SIDS in the world, with many of the narrow atoll islands being no more than 2 m above current high tide levels. Similar to the Tongan projects, the aim is to develop solutions that can be applied to similar locations with similar issues – in this case designing and constructing causeways that be built with local materials and plant. Many of the narrow atoll islands are being divided into smaller islands where narrow and low-lying parts are being eroded through. As a result, some inhabitants are literally stranded without access to medical facilities, airfields, unable to transport copra or get to local supply depots during mid-high tide and storm events.

Woja Island is very remote, accessible only through the once weekly flight or a ~36 hours boat journey from the main island of Majuro. Therefore, materials and methods for construction had to be conducive to what was available on site. Small diggers and trucks can be barged to site, however, fill material and structural units had to be sourced at the island.

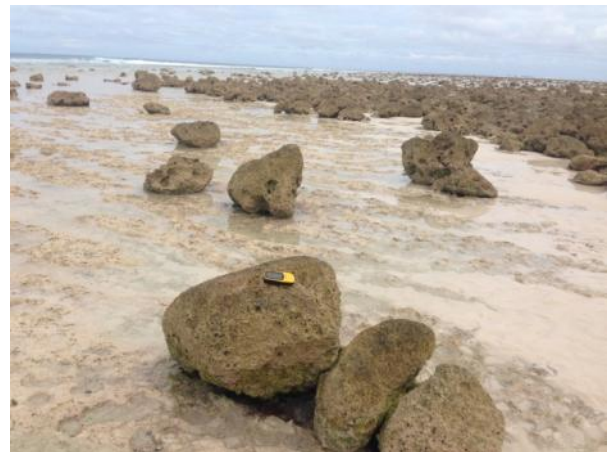
Figure 5 A large supply of rock is available on the north-western coast of Woja Atoll. The rock in the foreground is approximately 1.1 m diameter).
