Location: Tauranga, New Zealand
Client: Seahorse Beach Investments
Project Date: 2018

PROJECT DESCRIPTION:

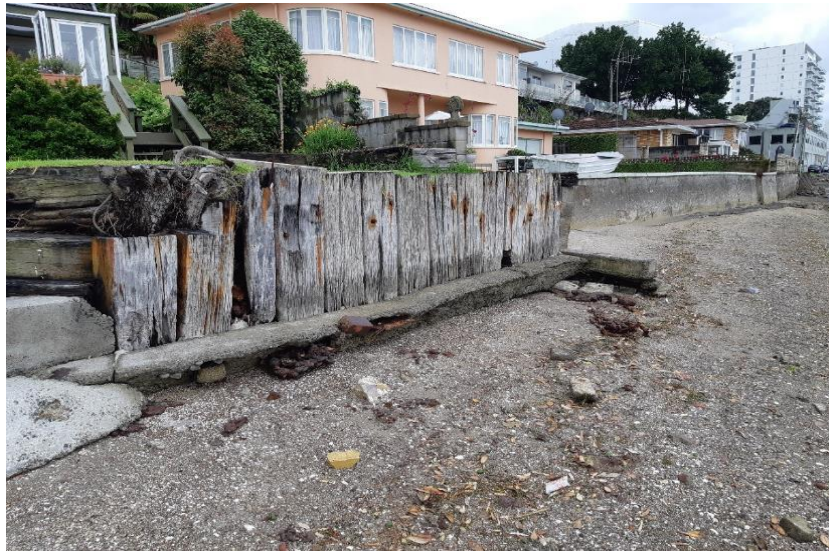
Existing seawall to be replaced.

eCoast was contracted by Stratum Consultants Ltd to provide an engineering design to replace a damaged seawall. A geotechnical site investigation was carried out to determine the underlying soil. The protocol for hazard assessment set out in the New Zealand Ministry for the Environment’s publication, “Coastal hazards and climate change: Guidance for local government. (MfE, 2017)”, was applied to the project site. A coastal hazard assessment provided the information required to determine the appropriate engineering design and strengths. The appropriate engineering design was provided out in a report.

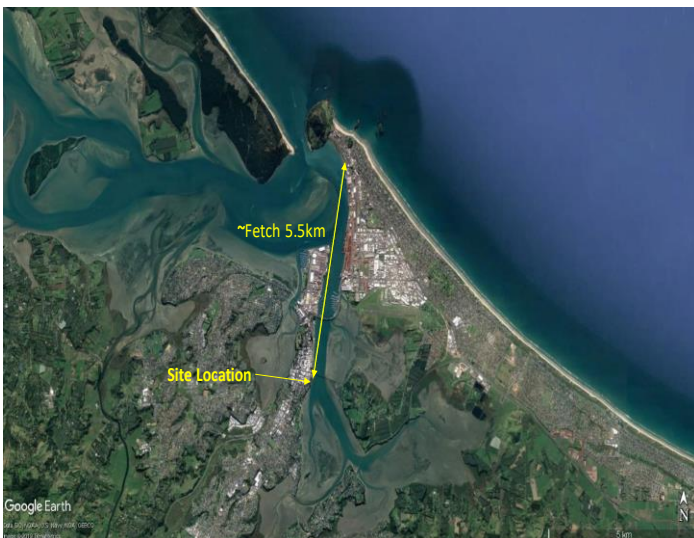
Left- Fetch limited coastal hazard assessment. Right – Proposed engineering design to replace existing seawall

- Geotechnical Investigation
- Coastal Hazard Assessment
- Extreme Wave Analysis
- Seawall Crest Level Assessment
